**SERMA TECHNOLOGIES**

**HAMAMATSU PHOTODIODES (DPD-S8576)  
EVALUATION N°4  
20 DPD's CYCLED BY HAMAMATSU  
REPORT E02P1443 - NOVEMBER, 2002**

**CEA  
Orme des Merisiers  
Bâtiment 709  
91191 GIF-SUR-YVETTE**

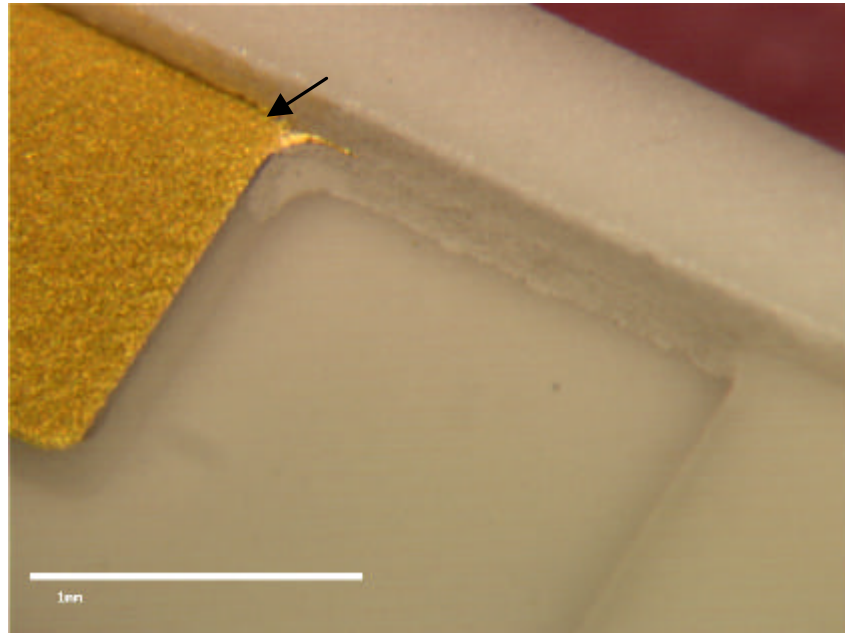
S/N 3

Delaminations (“peeling-off”) between epoxy and ceramic on 9 parts out of 10 and between epoxy and bonding area on 2 parts out of 10 were observed.

Figure 1. Details of delamination at epoxy/ceramic and epoxy/bonding area at T0, Lot H1.

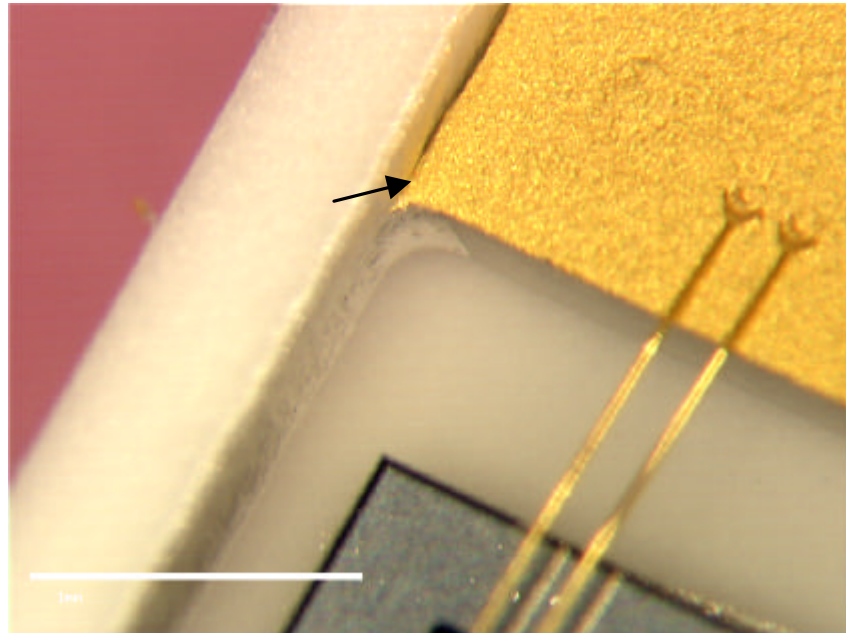
S/N 743

Delaminations (“peeling-off”) between epoxy and ceramic on 8 parts out of 10 and between epoxy and bonding area on one part were observed.

Figure 2. Details of delamination at epoxy/ceramic and epoxy/bonding area at T0, Lot H2.

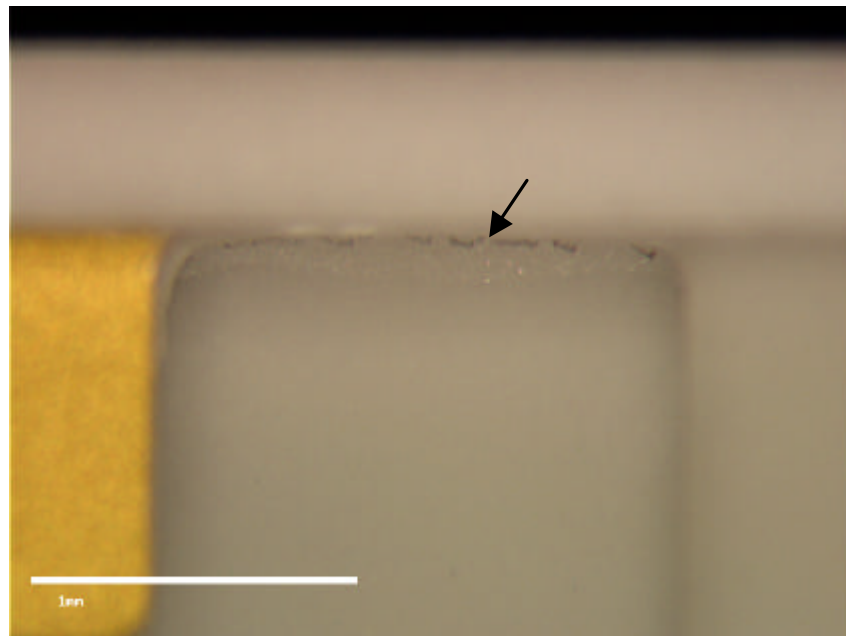
S/N 742

On the 5 parts submitted to the 40 additional thermal cycles, 3 out of 5 show a small increase of delaminations between epoxy and ceramic, and 4 out of 5 between epoxy and bonding area .No evolution was observed on one part.

Figure 3. Details of delamination at epoxy/ceramic and epoxy/bonding area, Lot H2 after 40 cycles.

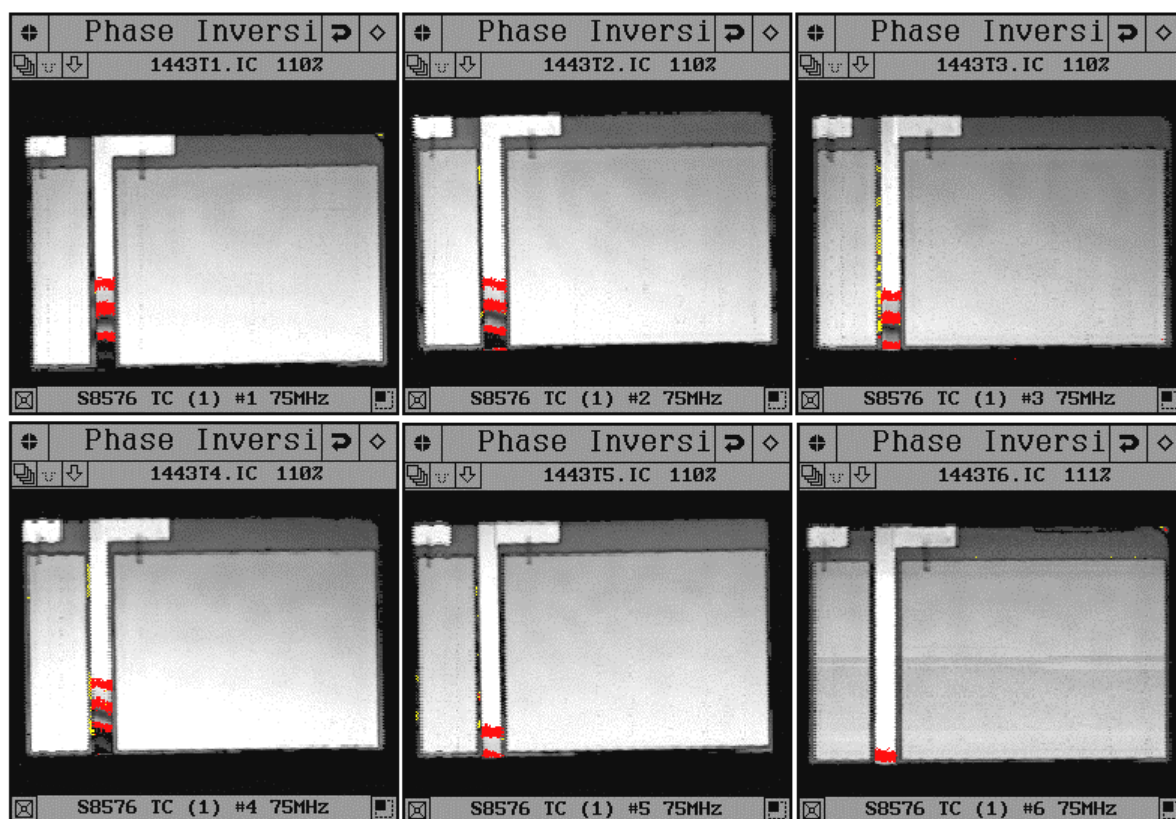
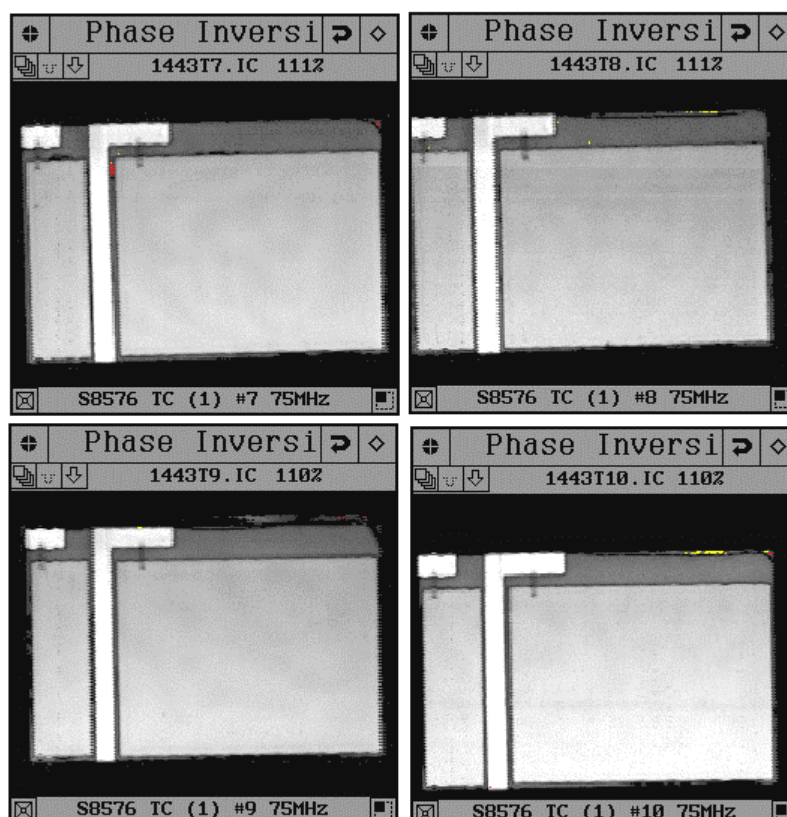
Acoustic analysis was performed top scanning, focus at epoxy/die and epoxy/ceramic interface. Delaminated areas are outlined in red or yellow, however, some red areas on separator or die were not delamination but signal perturbation due to very thin and irregular epoxy layer.

Beginning of delamination or only delaminated points at epoxy/ceramic interface were observed on 7 parts out of 10 were observed.

Figure 1. Acoustic microscopy, delamination images.  
Epoxy/die and epoxy/ceramic interfaces.  
Lot H1 (Parts 1 to 10) ; T<sub>0</sub>.

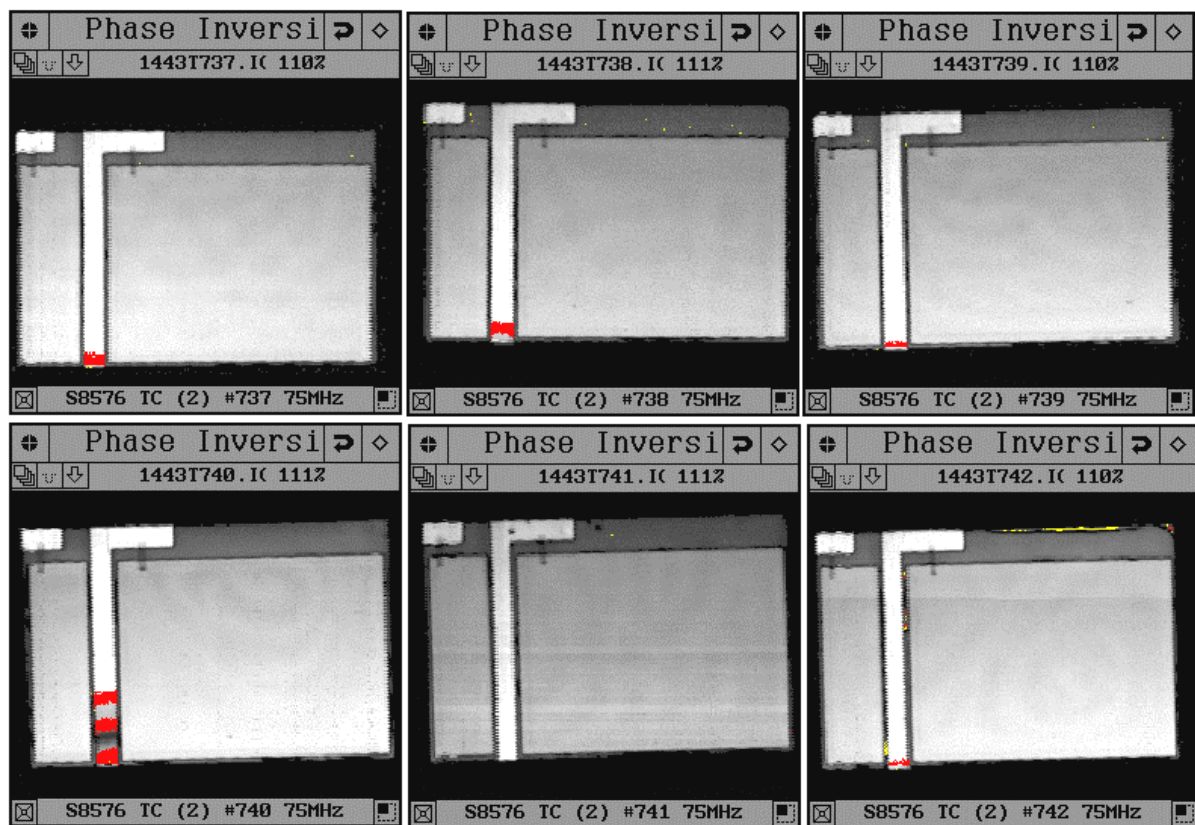
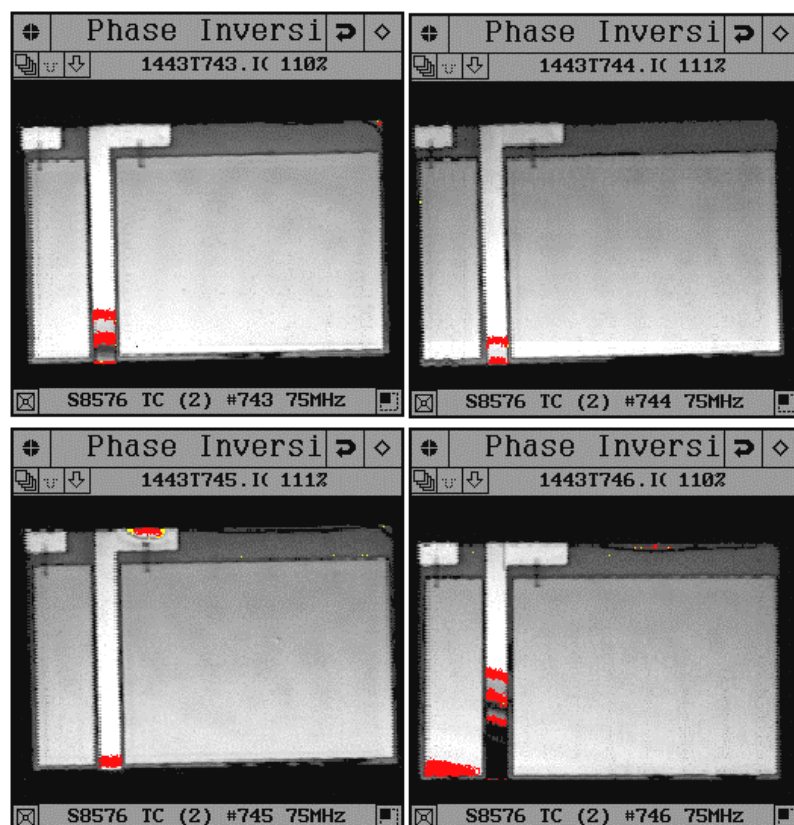
Beginning of delamination was observed at epoxy/ceramic interface on 3 parts out of 10 . Partial delamination at epoxy/ bonding area was detected on 1 part out of 10.

Figure 2. Acoustic microscopy, delamination images.  
Epoxy/die and epoxy/ceramic interfaces.  
Lot H2 (Parts 737 to 746) ; T<sub>0</sub>.

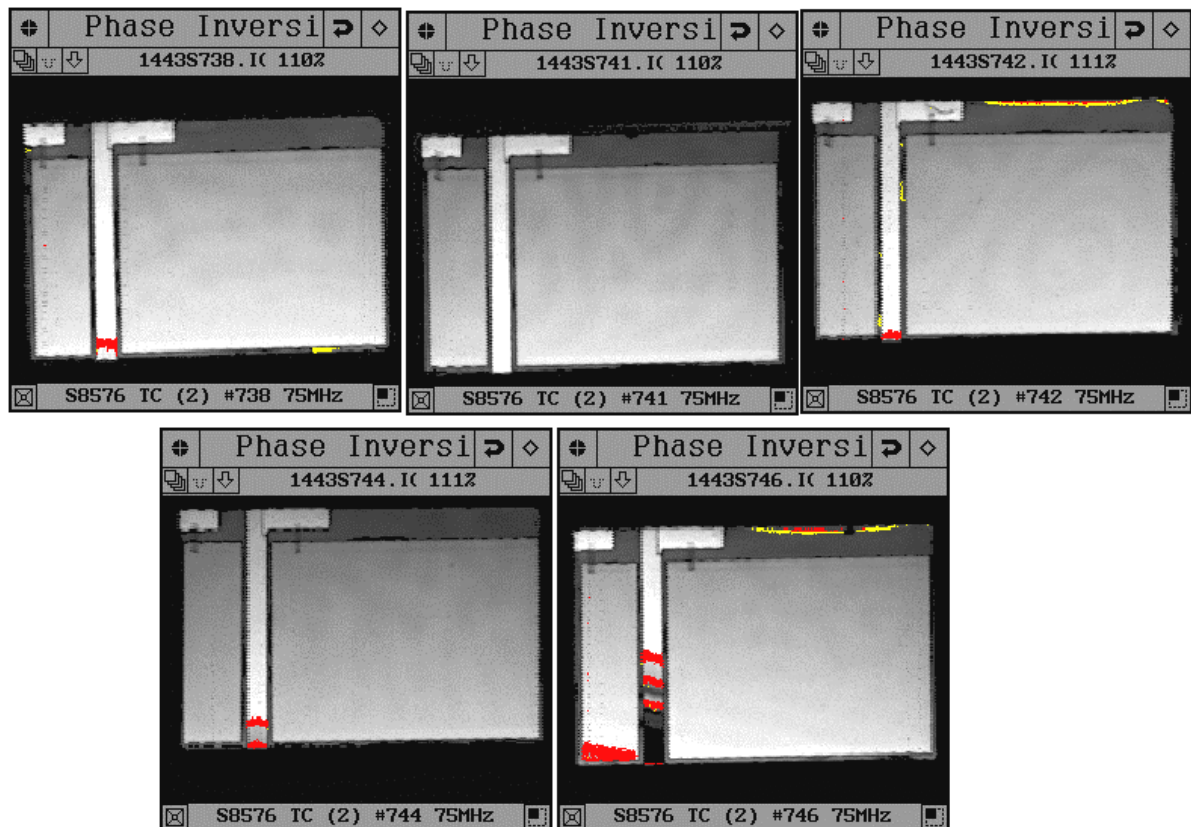
After the 40 additional thermal cycles, a small increase of delamination at epoxy/ceramic interface was observed on 3 parts, there is no evolution on the 2 others:

Figure 3. Acoustic microscopy, delamination images.  
Epoxy/die and epoxy/ceramic interfaces.  
Lot H2 (Parts 738,741,742,744 and 746) ; T<sub>1</sub>.

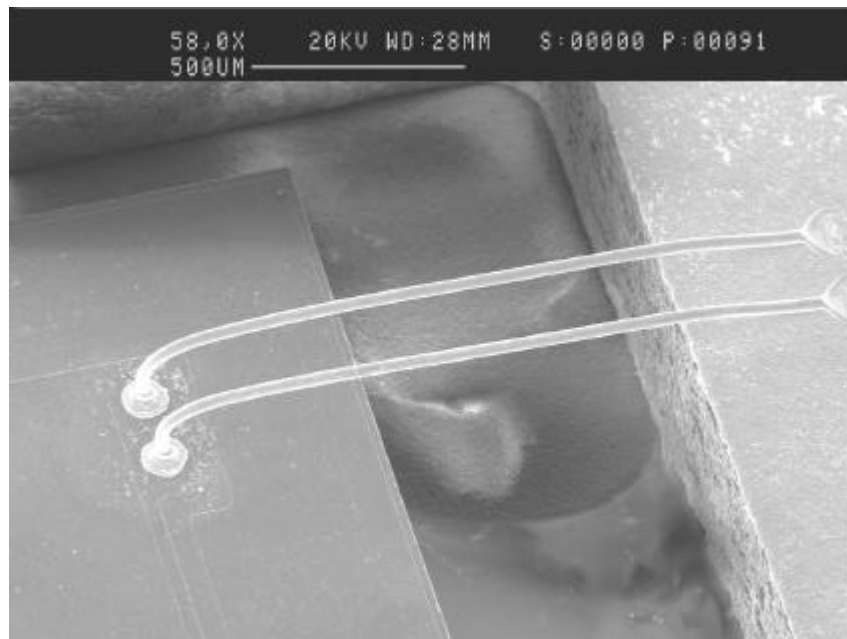
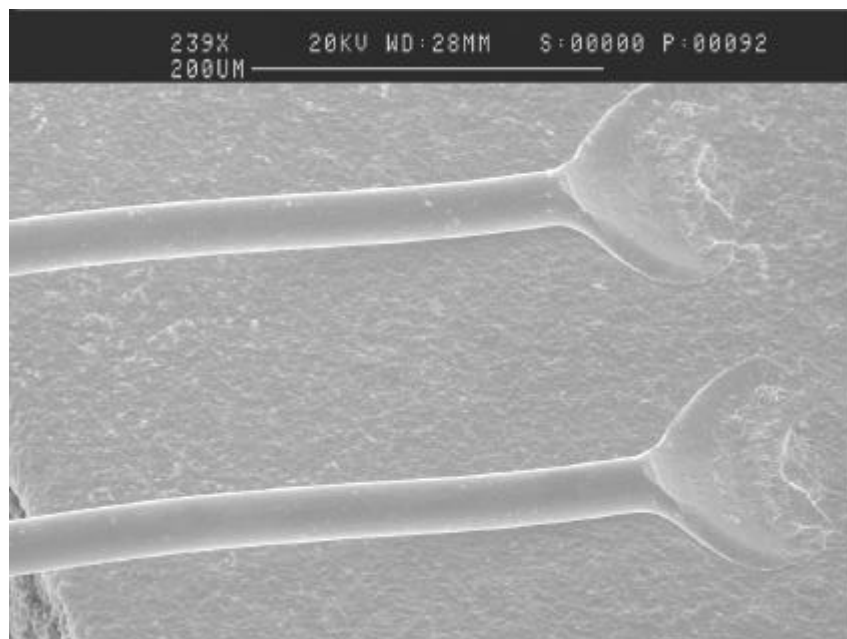
No degradation of the wire bonding was evidenced.

The wire bonding thinning observed on the previous analysis ( DR3 ) was not present on these parts.

Figure 1. SEM views of the wire bonding, Pin A, # 9.  
Top : mag 58X ; bottom : mag 239X.

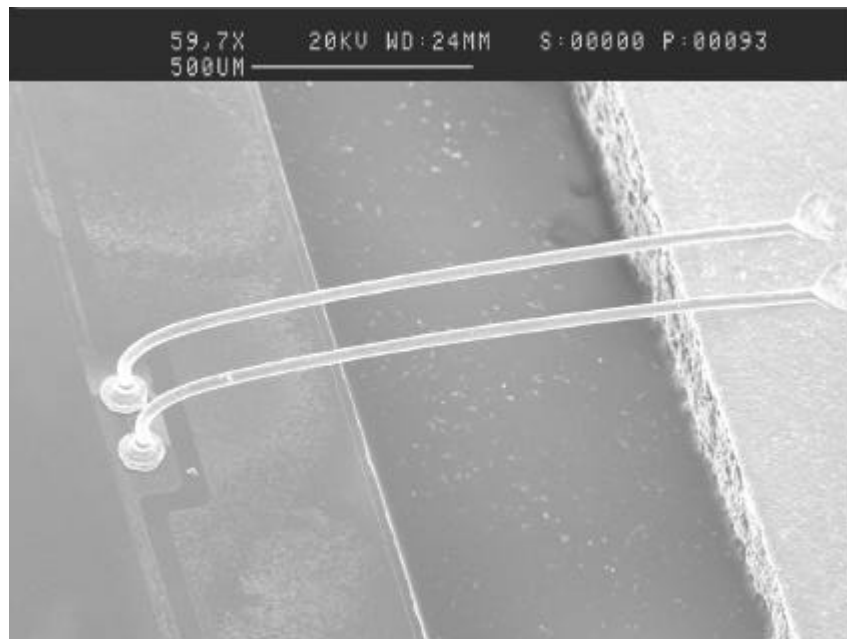
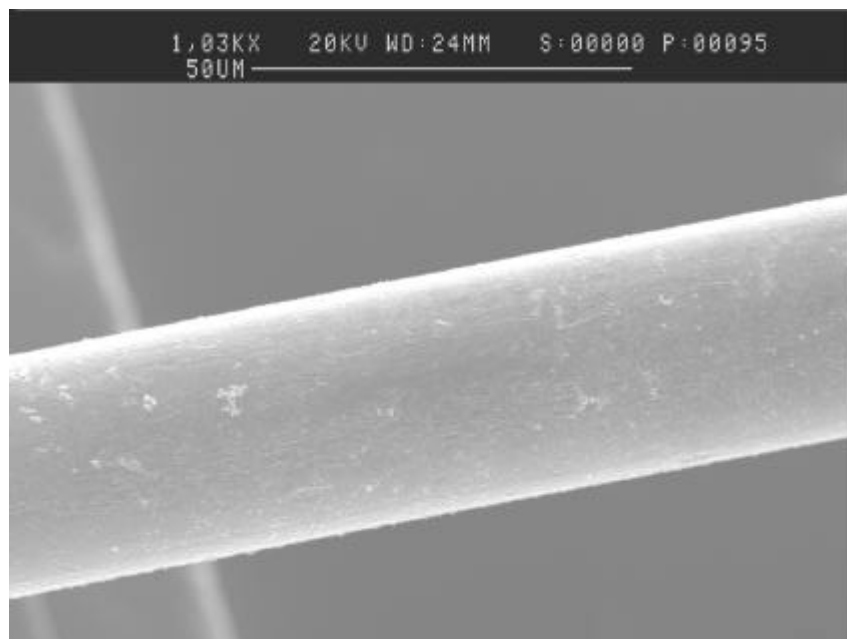
Figure 2. SEM views of the wire bondings, Pin B, # 9.  
Top : mag 60X ; bottom : mag 1030X.

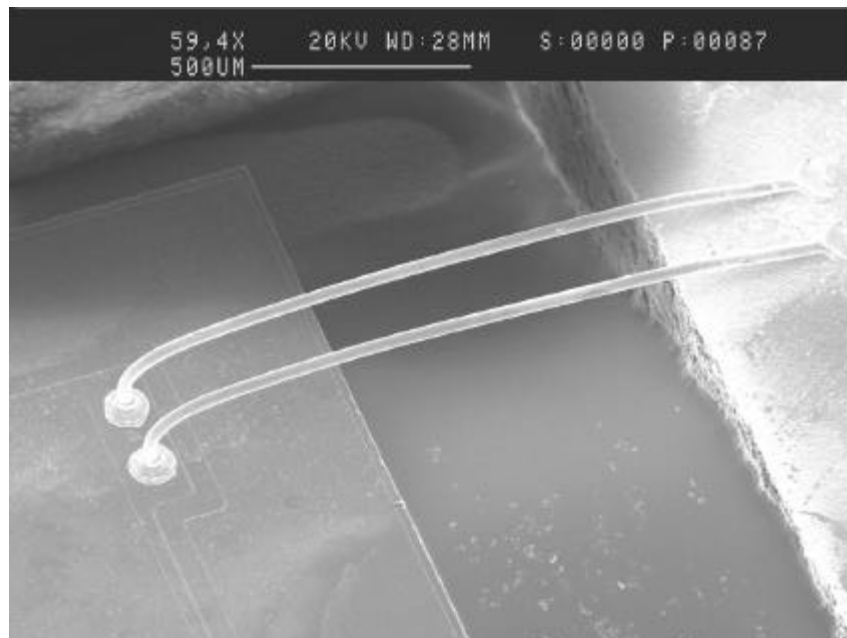
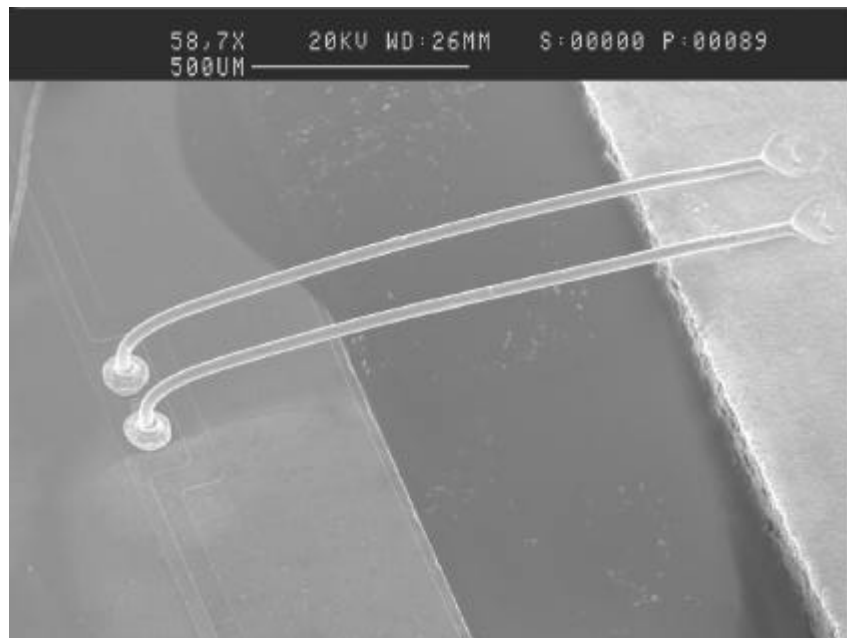
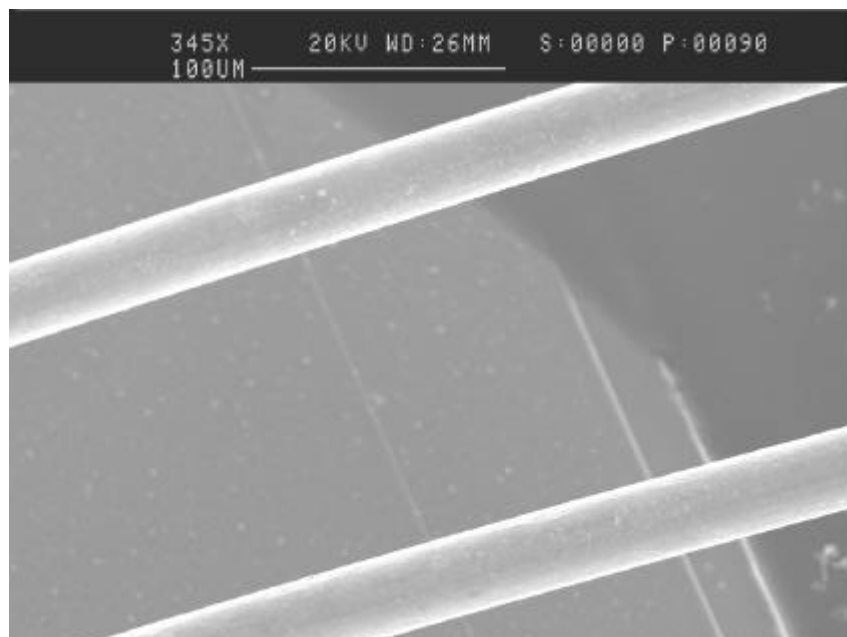
Figure 3. SEM views of the wire bondings, Pin A and Pin B, # 0745.  
Top and center : mag 59X ; bottom : mag 345X.
